West Fork Village O.A. Inc.
Greeley, CO

Report #: 28501-4
Beginning: January 1, 2026
Expires: December 31, 2026

RESERVE STUDY
Update "With-Site-Visit"

March 6, 2025

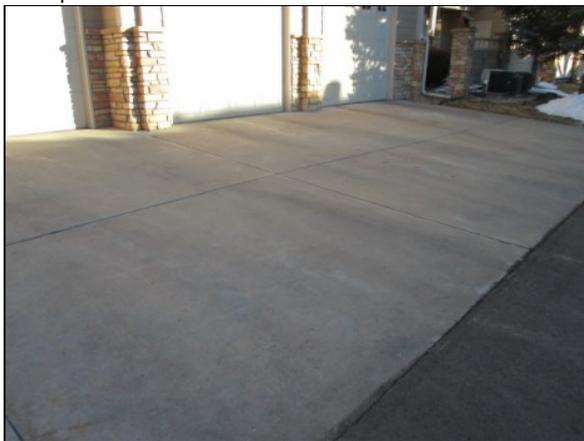
Comp #: 21050 Driveway Concrete - Repair - 5%

Useful Life:
5 years

Remaining Life:
0 years

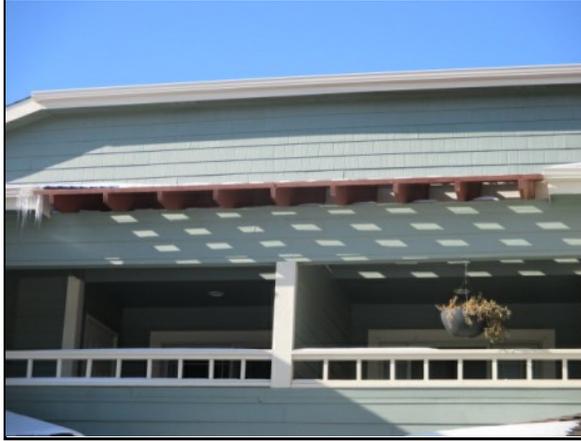
Comments: Pergola structures determined to be in fair condition typically exhibit more wear and tear, possibly including some warped, split and/or deteriorated components. Framework/structure should still be sturdy but may have sections showing minor leaning or damage. As routine maintenance, inspect regularly and repair individual pieces or sections as needed from general Operating funds. Clean and paint/stain along with other larger projects or as general maintenance to preserve the appearance of the pergola and extend its useful life. If present, vegetation should be well-maintained and not allowed to become overgrown, which can eventually compromise the structure. Assuming ordinary care and maintenance, plan for major repairs or possibly complete replacement (if warranted) at roughly the interval indicated below.

Useful Life:
30 yearsRemaining Life:
7 years

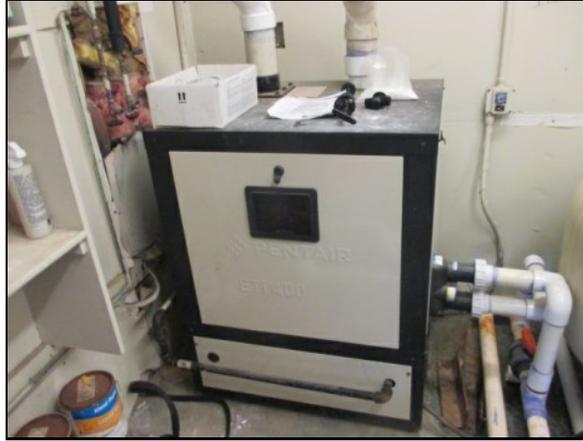
Pool vendor should inspect heater regularly to ensure proper function, identify any required repairs, etc. Internal components were not analyzed during our site inspection, but typical signs of age and failure include rusting and corrosion around the burners, worn electrical components, etc. Many associations choose not to heat their pools year-round, which can prolong the life of the heater while reducing energy costs. When replacement models are being evaluated, we recommend considering high efficiency models which may have a higher initial cost but will ultimately be less expensive due to reduced energy usage.

Useful Life:
12 yearsRemaining Life:
5 years

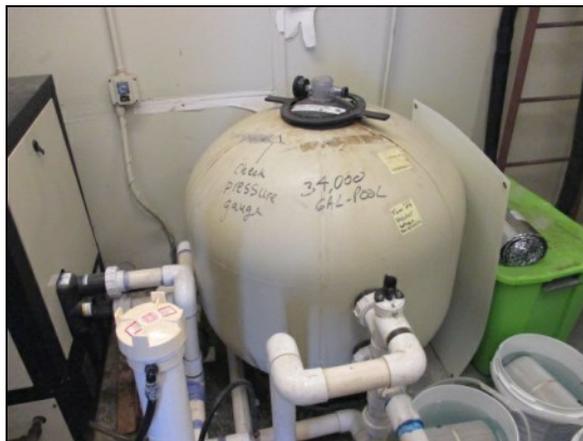
Comments: Vendor should inspect regularly for optimal performance and address any repairs or preventive maintenance as needed. Life can vary depending on location, as well as level of use and preventive maintenance. Plan to replace at the approximate interval shown below.

Useful Life:
20 yearsRemaining Life:
0 years
