West Fork Village O.A. Inc.
Greeley, CO

Report #: 28501-4
Beginning: January 1, 2026
Expires: December 31, 2026

RESERVE STUDY
Update "With-Site-Visit"

March 6, 2025

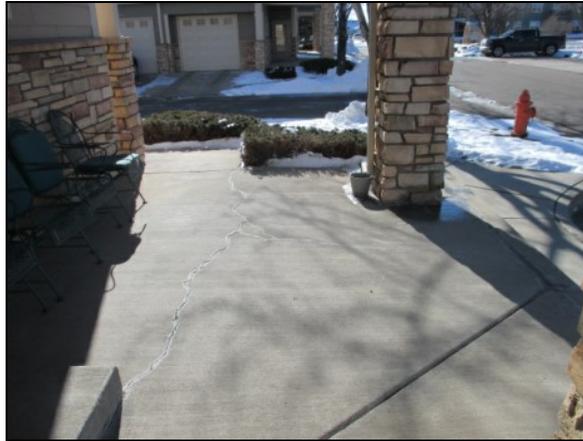
Comments: Concrete decks determined to be in fair condition typically exhibit minor changes in slope and a moderate percentage of cracking and surface wear. Trip hazards may be increasing in frequency and severity and should be closely monitored to prevent further risks. The Rocky Mountain Region is home to expansive soils. One of the causes of concrete damage in this type of climate is soil moisture. Expansive soils tend to swell in size when wet and contract as they dry out. As the soil expands and contracts it can create enough force to cause major damage to sidewalks. Repair any trip and fall hazards immediately to ensure safety. As routine maintenance, inspect regularly, pressure wash for appearance and repair promptly as needed to prevent water penetrating into the base and causing further damage. In our experience, larger repair/replacement expenses emerge as the community ages. Although difficult to predict timing, cost and scope, we suggest a rotating funding allowance to supplement the operating/maintenance budget for periodic larger repairs. Adjust as conditions, actual expense patterns dictate within future reserve study updates.

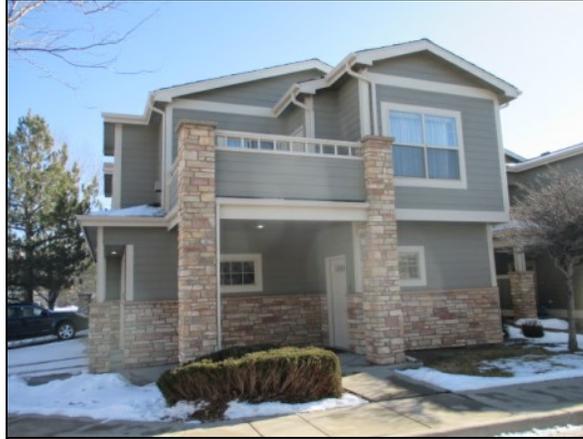
Comp #: 23160 Balcony Deck - Seal/Repair (2013)

Comments: The association has started to replace the deck surfaces with truck bed liner material. Even with regular preventive maintenance (cleaning/repairing/sealing), decking system will eventually wear down to the point of failure. If not resurfaced or replaced with a new system, water penetration can damage the building structure. Typical warning signs that the surface may be failing include large cracks visible on surface or from beneath the deck, staining patterns, spalling/chipping (for concrete decks) and exposed framing, among others. Sub-surface evaluation including moisture testing is outside the scope of this Reserve Study engagement. The association should consult with a decking or waterproofing contractor when evaluating scope of work in order to properly define any necessary structural repairs/restoration. Funding recommendations shown here should be updated based on any new analysis/information provided by more comprehensive evaluations.

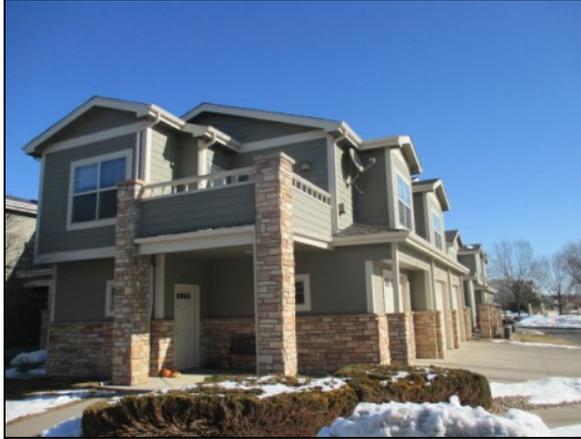
Comp #: 23161 Balcony Deck - Seal/Repair (2014)

Comments: The association has started to replace the deck surfaces with truck bed liner material. Even with regular preventive maintenance (cleaning/repairing/sealing), decking system will eventually wear down to the point of failure. If not resurfaced or replaced with a new system, water penetration can damage the building structure. Typical warning signs that the surface may be failing include large cracks visible on surface or from beneath the deck, staining patterns, spalling/chipping (for concrete decks) and exposed framing, among others. Sub-surface evaluation including moisture testing is outside the scope of this Reserve Study engagement. The association should consult with a decking or waterproofing contractor when evaluating scope of work in order to properly define any necessary structural repairs/restoration. Funding recommendations shown here should be updated based on any new analysis/information provided by more comprehensive evaluations.

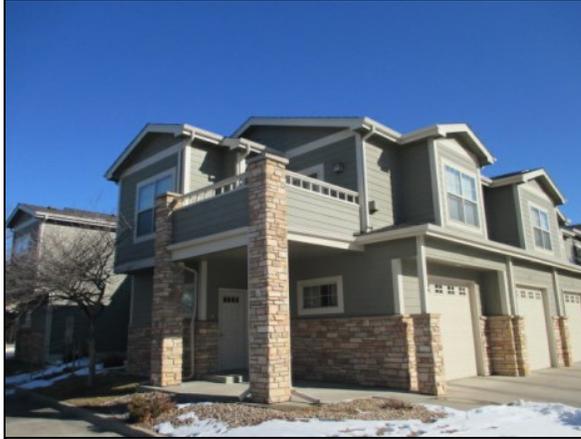
Comp #: 23162 Balcony Deck - Seal/Repair (2015)

Comments: The association has started to replace the deck surfaces with truck bed liner material. Even with regular preventive maintenance (cleaning/repairing/sealing), decking system will eventually wear down to the point of failure. If not resurfaced or replaced with a new system, water penetration can damage the building structure. Typical warning signs that the surface may be failing include large cracks visible on surface or from beneath the deck, staining patterns, spalling/chipping (for concrete decks) and exposed framing, among others. Sub-surface evaluation including moisture testing is outside the scope of this Reserve Study engagement. The association should consult with a decking or waterproofing contractor when evaluating scope of work in order to properly define any necessary structural repairs/restoration. Funding recommendations shown here should be updated based on any new analysis/information provided by more comprehensive evaluations.

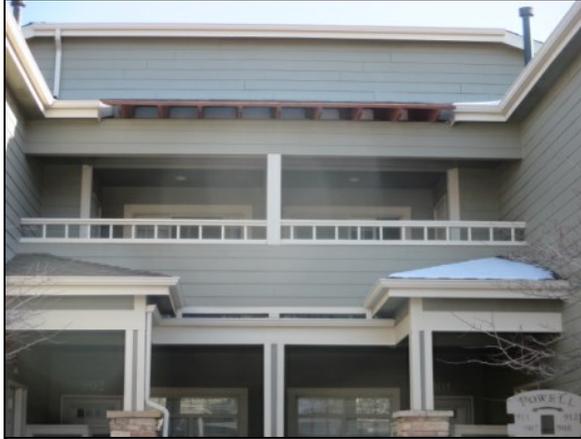
Comp #: 23163 Balcony Deck - Seal/Repair (2016)

Comments: The association has started to replace the deck surfaces with truck bed liner material. Even with regular preventive maintenance (cleaning/repairing/sealing), decking system will eventually wear down to the point of failure. If not resurfaced or replaced with a new system, water penetration can damage the building structure. Typical warning signs that the surface may be failing include large cracks visible on surface or from beneath the deck, staining patterns, spalling/chipping (for concrete decks) and exposed framing, among others. Sub-surface evaluation including moisture testing is outside the scope of this Reserve Study engagement. The association should consult with a decking or waterproofing contractor when evaluating scope of work in order to properly define any necessary structural repairs/restoration. Funding recommendations shown here should be updated based on any new analysis/information provided by more comprehensive evaluations.

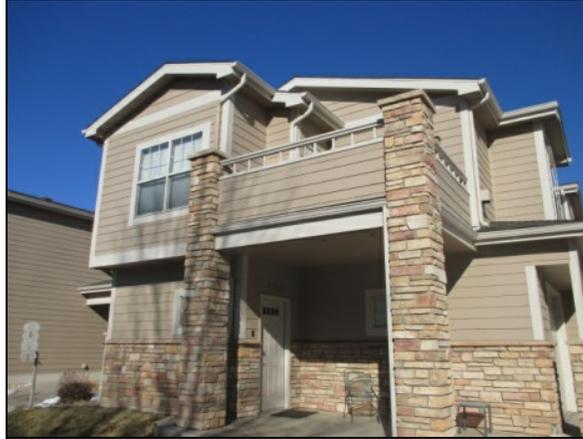
Comp #: 23164 Balcony Deck - Seal/Repair (2017A)

Comments: The association has started to replace the deck surfaces with truck bed liner material. Even with regular preventive maintenance (cleaning/repairing/sealing), decking system will eventually wear down to the point of failure. If not resurfaced or replaced with a new system, water penetration can damage the building structure. Typical warning signs that the surface may be failing include large cracks visible on surface or from beneath the deck, staining patterns, spalling/chipping (for concrete decks) and exposed framing, among others. Sub-surface evaluation including moisture testing is outside the scope of this Reserve Study engagement. The association should consult with a decking or waterproofing contractor when evaluating scope of work in order to properly define any necessary structural repairs/restoration. Funding recommendations shown here should be updated based on any new analysis/information provided by more comprehensive evaluations.

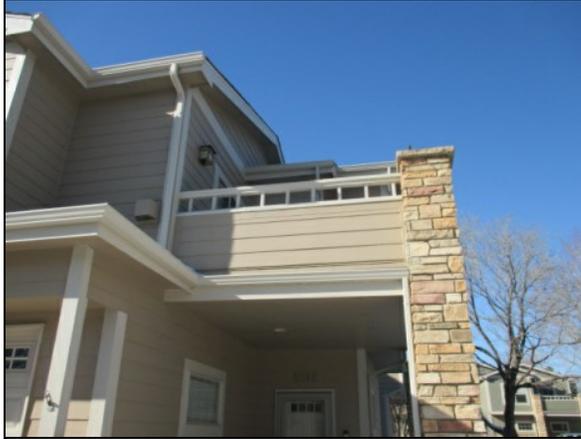
Comp #: 23165 Balcony Deck - Seal/Repair (2017B)

History: Repaired in 2019

Comments: The association has started to replace the deck surfaces with truck bed liner material. Even with regular preventive maintenance (cleaning/repairing/sealing), decking system will eventually wear down to the point of failure. If not resurfaced or replaced with a new system, water penetration can damage the building structure. Typical warning signs that the surface may be failing include large cracks visible on surface or from beneath the deck, staining patterns, spalling/chipping (for concrete decks) and exposed framing, among others. Sub-surface evaluation including moisture testing is outside the scope of this Reserve Study engagement. The association should consult with a decking or waterproofing contractor when evaluating scope of work in order to properly define any necessary structural repairs/restoration. Funding recommendations shown here should be updated based on any new analysis/information provided by more comprehensive evaluations.

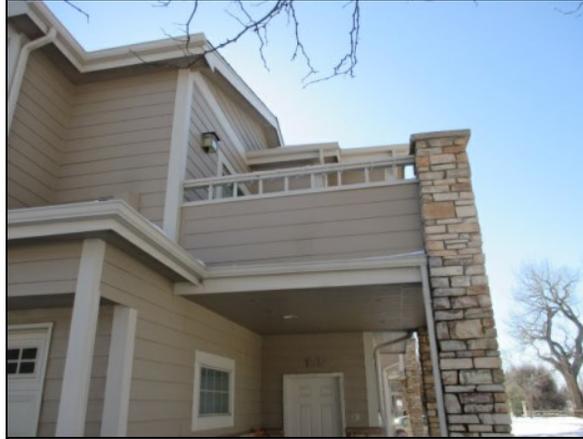
Comp #: 23166 Balcony Deck - Seal/Repair (2024)

History: Replaced in ~2024, per the client.

Comments: The association has started to replace the deck surfaces with truck bed liner material. Even with regular preventive maintenance (cleaning/repairing/sealing), decking system will eventually wear down to the point of failure. If not resurfaced or replaced with a new system, water penetration can damage the building structure. Typical warning signs that the surface may be failing include large cracks visible on surface or from beneath the deck, staining patterns, spalling/chipping (for concrete decks) and exposed framing, among others. Sub-surface evaluation including moisture testing is outside the scope of this Reserve Study engagement. The association should consult with a decking or waterproofing contractor when evaluating scope of work in order to properly define any necessary structural repairs/restoration. Funding recommendations shown here should be updated based on any new analysis/information provided by more comprehensive evaluations.

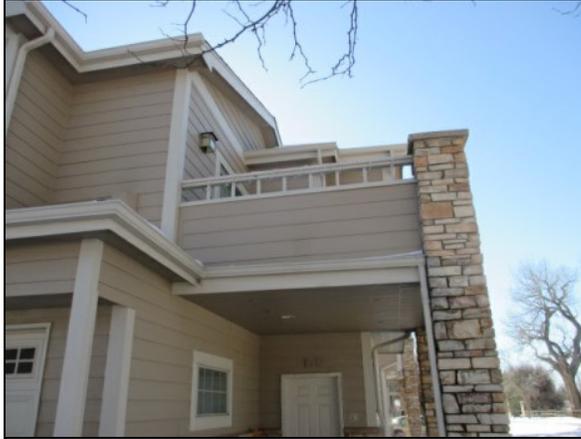
Comp #: 23167 Balcony Deck - Seal/Repair

Comments: The association has started to replace the deck surfaces with truck bed liner material. Even with regular preventive maintenance (cleaning/repairing/sealing), decking system will eventually wear down to the point of failure. If not resurfaced or replaced with a new system, water penetration can damage the building structure. Typical warning signs that the surface may be failing include large cracks visible on surface or from beneath the deck, staining patterns, spalling/chipping (for concrete decks) and exposed framing, among others. Sub-surface evaluation including moisture testing is outside the scope of this Reserve Study engagement. The association should consult with a decking or waterproofing contractor when evaluating scope of work in order to properly define any necessary structural repairs/restoration. Funding recommendations shown here should be updated based on any new analysis/information provided by more comprehensive evaluations.

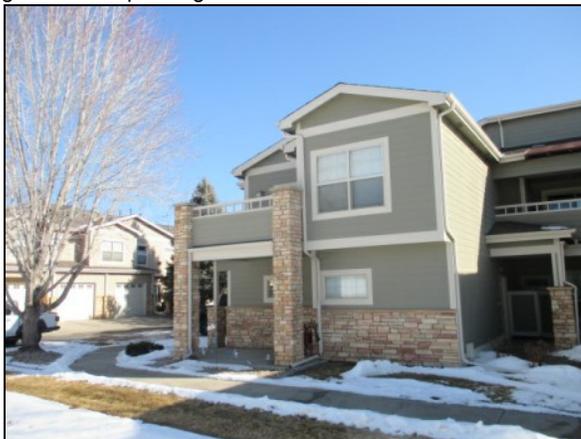
Wood railings. Balcony railings should be painted/re-coated at the approximate interval shown below in order to restore good appearance and protect the railings from excessive surface wear. If railing is exposed to the elements without adequate coating for an extended period of time, useful life may be severely reduced. Best practice is to coordinate with other exterior projects when possible, such as balcony sealing or exterior painting.

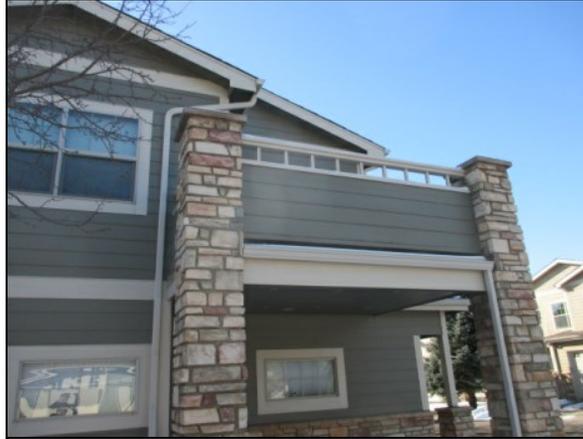
Comp #: 23230 Balcony/Patio Rails - Replace

Comments: Deck railings determined to be in fair condition typically exhibit some wear and age, but are not showing any advanced structural concerns, loose attachments, rust, etc. Appearance may be declining or outdated at this stage, but railings are still performing their intended function. Post attachments and hardware should be inspected periodically for corrosion/rust and any waterproofing issues. As routine maintenance, inspect regularly to ensure safety and stability repair promptly as needed using general operating/maintenance funds. We suggest Reserve funding for regular intervals of total replacement as indicated below. Unless otherwise noted, costs shown are based on replacement with a similar style of railing. However, if the client chooses to upgrade or replace with a different style, costs may be substantially different. Any new information about changes in style should be incorporated into future Reserve Study updates.

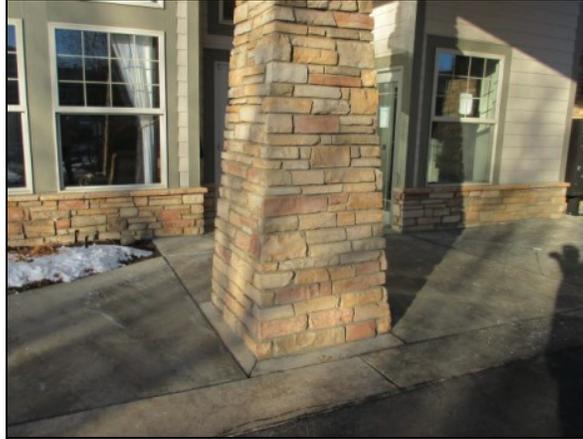
Comp #: 23370 Stone Veneer - Maintain/Repair

Comments: Brick or other masonry siding is typically a low maintenance surface that requires minimal, infrequent repair. However, in some cases (usually after several decades or more), the original mortar between bricks may require repointing to restore appearance and adequately protect against water intrusion. Repointing involves raking out a portion of the existing mortar and installing new mortar and continuing on until all affected sections have been replaced. In our experience, there is not a well-defined predictable timeline for repointing work, usually making this project inappropriate for Reserve funding. If re-pointing is a concern, we strongly recommend further inspection by a qualified engineer and/or masonry specialist to diagnose existing conditions and recommend a scope of work. If warranted, the Reserve Study can be adjusted to include funding recommendations going forward.

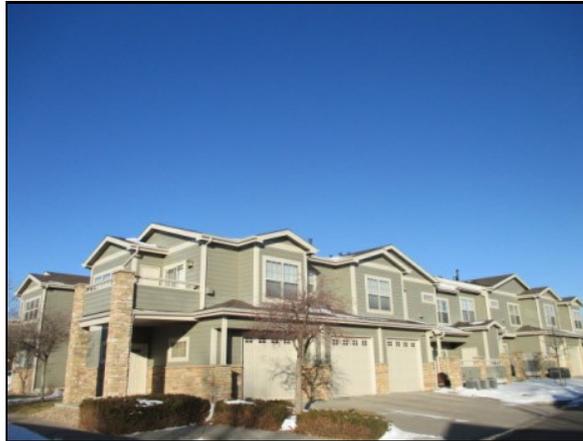
Comments: Fiber cement siding/trim sections determined to be in poor condition typically exhibit a poor appearance with advanced deterioration of any surface coatings. At this stage, painting/sealing is required in the near future in order to prevent further deterioration of the material, which can lead to more costly repairs. Association Reserves does not specifically endorse any products, manufacturers or vendors, but James Hardie Building Products, Inc. is the leading manufacturer of fiber cement siding, and their website (www.jameshardie.com) is an informative resource for proper care and maintenance of fiber cement siding. Their Best Practices guidelines recommend the use of primers and topcoats that are designed and recommended for cement-based building materials such as fiber cement, masonry, brick or stucco. Two finish coats of high-quality exterior-grade acrylic paint are recommended. Their guidelines also recommend the use of elastomeric joint sealants complying with ASTM C920 Grade NS, Class 25 or higher, or latex joint sealants complying with ASTM C834. We recommend that the client consult with qualified exterior painting/waterproofing consultants and/or contractors to ensure that proper materials are used in painting and sealing the building siding. Plan for such projects at the interval shown here.

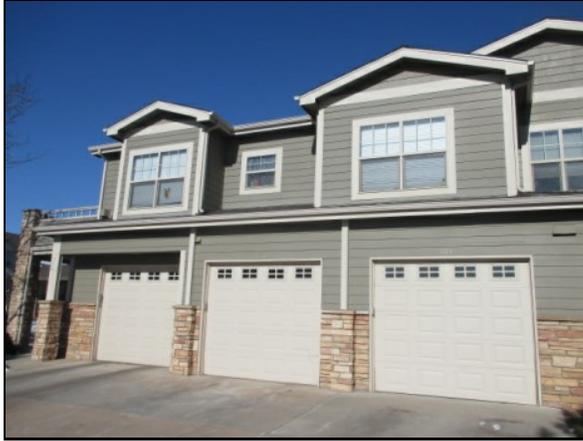
Comments: Fiber cement siding/trim sections determined to be in fair to poor condition typically exhibit some color fading and inconsistency, with minor, isolated locations showing more advanced surface wear, cracking, splintering, etc. Association Reserves does not specifically endorse any products, manufacturers or vendors, but James Hardie Building Products, Inc. is the leading manufacturer of fiber cement siding, and their website (www.jameshardie.com) is an informative resource for proper care and maintenance of fiber cement siding. Their Best Practices guidelines recommend the use of primers and topcoats that are designed and recommended for cement-based building materials such as fiber cement, masonry, brick or stucco. Two finish coats of high-quality exterior-grade acrylic paint are recommended. Their guidelines also recommend the use of elastomeric joint sealants complying with ASTM C920 Grade NS, Class 25 or higher, or latex joint sealants complying with ASTM C834. We recommend that the client consult with qualified exterior painting/waterproofing consultants and/or contractors to ensure that proper materials are used in painting and sealing the building siding. Plan for such projects at the interval shown here.

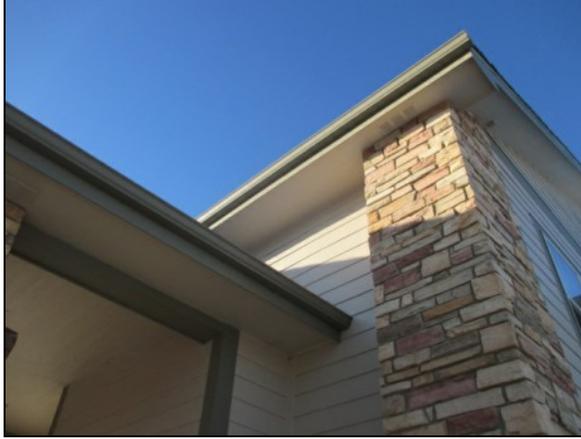
Comp #: 23650 Clubhouse Gutters/Downspouts - Replace

Comments: Generally the metal gutters and downspouts appeared in good condition. We recommend that the adjacent gutter be replaced when the roof (or decks) is being resurfaced. National Roofing Contractor Association (NRCA) roofing standard includes installing eave flashings at the gutters. We suggest to plan for total replacement of gutter and downspouts at the same intervals as roof replacement for cost efficiency. Evaluate at time of roofing to determine if replacement or re-use is the better value. As routine maintenance, inspect regularly, keep gutters and downspouts free of debris.

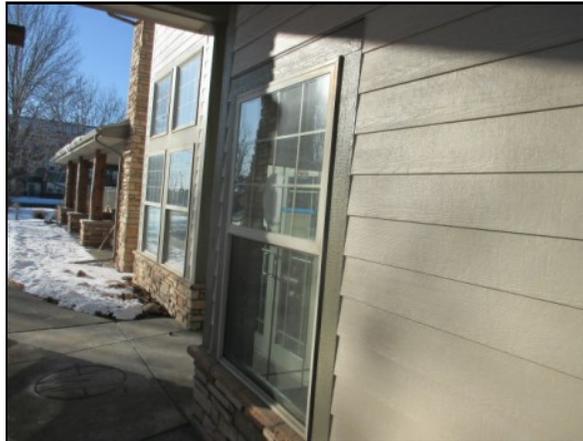
Comp #: 27060 Clubhouse Windows - Replace

Comments: Windows were Milgard vinyl framed. Head flashing was observed. Jamb and sills had sealant joint between window frame and cladding. No condensation was observed between window panes, which is typically indicative of failed glazing seals. Factors effecting useful life include: quality of windows and installation, waterproofing flashing details, exposure to wind driven rain, building movement over time, structural details, etc... We recommend financially planning for a 30-year useful life range timed with other large scale building exterior projects for efficiency. Schedule can be modified as the remaining useful life approaches zero years and the aging of the windows and sliding doors is more apparent. Note: there are many types of glazing and windows types, material and quality, available in today's market; and costs can vary greatly. Inspect regularly, including sealant, if any, and repair as needed. Keep weep holes free and clear to allow proper drainage of water that gets into window frame. Do not block (caulk or seal) gap at top of head flashing, as this allows water that gets behind the siding, to drain out. Proper sealant/caulking is critical to keeping water out of the walls, and preventing water damage. Two common types of sealants/caulking are urethane and silicone. If properly installed, urethane has a life of approximately 6-8 years and silicone's life can be 16-20 years. Incorrect installation of sealant is common, and can greatly decrease its useful life. Inspect sealant, more frequently as it ages, to determine if it is failing. Typical sealant failures include; lack of adherence to adjacent materials, tearing/splitting of the sealant itself, and lose of elastic ability. Lose of elastic ability can be caused by exposure to ultra-violet light and general aging. Remove and replace all sealants as signs of failure begin to appear. Proper cleaning, prep work, and proper installation are critical for a long lasting sealant/caulking. One of the most important factors in selection window is the design pressure rating. The design pressure rating (DP) is the ability of the window to withstand wind blown rain, and a few other criteria. Manufacturers can choose to have a sample of their windows tested. Independent third parties perform testing following American Architectural Manufacturers Association (AAMA) standards and procedures. AAMA stickers are placed on windows with the specific DP rating (psf) and largest size of the window that meets the design pressure. No AAMA stickers were found on the few windows sampled for this report.

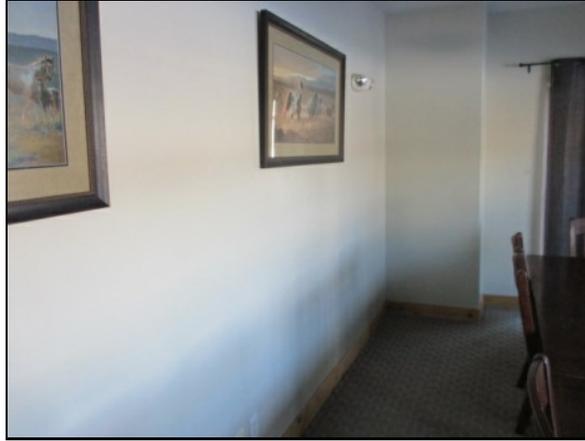
Interior areas determined to be in fair condition typically exhibit some minor, routine marks and scuffs, small sections of peeling paint, etc. Overall appearance is satisfactory. Regular cycles of professional painting are recommended to maintain appearance. Small touch-up projects can be conducted as needed as a maintenance expense, but comprehensive painting of interior areas will restore a consistent look and quality to all areas. Best practice is to coordinate at same time as other interior projects (flooring, furnishings, lighting, etc.) whenever possible to minimize downtime and maintain consistent quality standard.

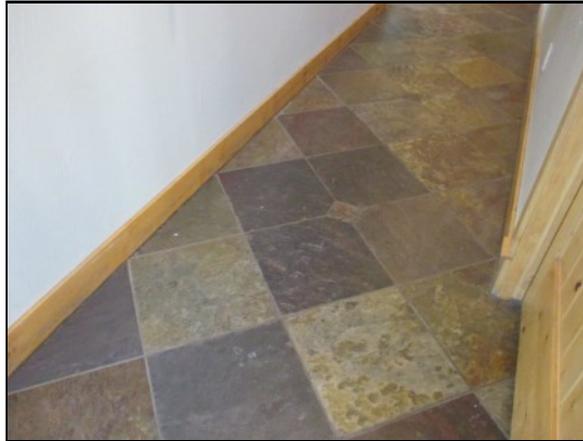
Comp #: 24070 Tile Flooring - Replace

Comments: Tiled surfaces were determined to be in fair condition. Floors did not exhibit any extensive un-even or broken sections. No evidence of heavy deterioration or broken tiles. As part of ongoing maintenance program, inspect regularly, repairing or replacing damaged sections as needed. If available, best practice is to keep a collection of replacement tiles on hand for partial replacements. With ordinary care and maintenance, tile in interior locations can last for an extended period of time, but replacement is often warranted eventually to enhance and restore aesthetic appeal in the common areas. Replacement costs can vary greatly depending on size and type of tiles selected. Our recommendation is to replace at the approximate schedule shown here, but this schedule can be adjusted at the client's discretion.

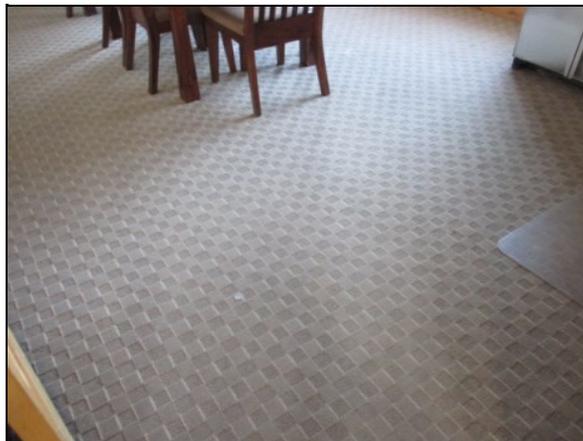
Comp #: 24080 Carpeting - Replace

Comments: Carpeting was noted to fairly stained and in generally poor condition. Plan to replace at the time frame below, best timed after repainting (see separate component). Wide variety of type and quality available; a mid-range funding allowance is factored below for planning purposes. As part of ongoing maintenance program, vacuum regularly and professionally clean as needed.

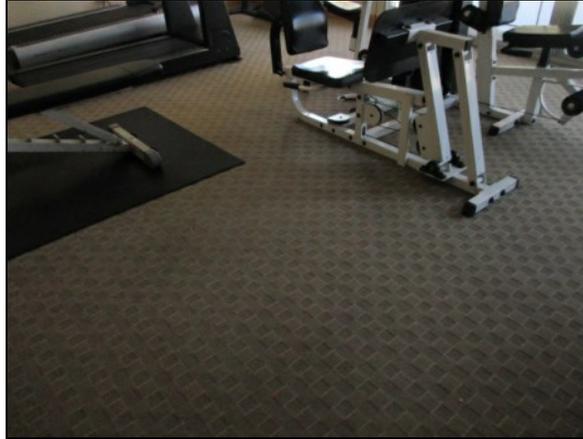
Comp #: 24080 Fitness Carpeting - Replace

Comments: Carpeted surfaces were determined to be in fair condition. Minor evidence of staining, matting, or loose seams observed. As part of ongoing maintenance program, vacuum regularly and professionally clean as needed. Best practice is to coordinate at same time as other interior projects whenever possible to minimize downtime and maintain consistent quality standard. Timing and interval is somewhat subjective, but not as flexible as other flooring finishes (tile, wood, etc.). Estimates shown here are based on our experience with similar properties and general aesthetic qualities. Schedule can be updated/adjusted at the discretion of the client for planning purposes.

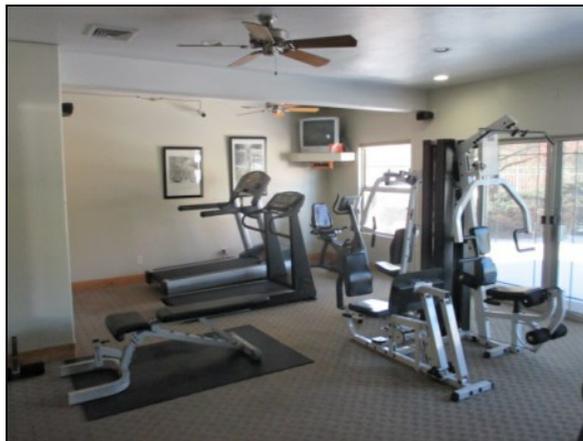
Comp #: 24150 Fitness Equipment - Replace

Inspect regularly, clean for appearance, maintain and repair promptly as needed from Operating budget to ensure safety. Commercial-grade equipment should have a relatively long functional life assuming proper maintenance. Replacement may be warranted from an aesthetic/quality standpoint before equipment fails to take advantage of new technology and maintain an attractive, desirable amenity.

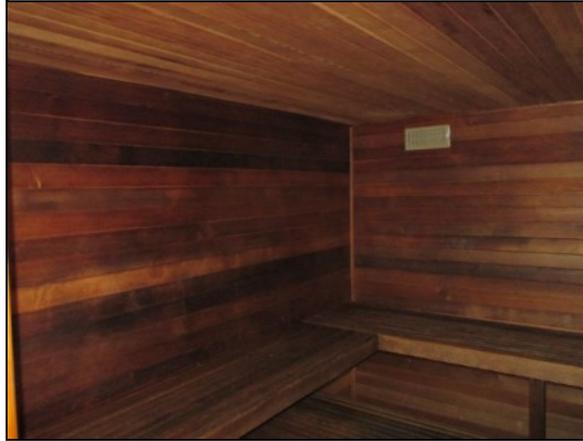
Comments: Sauna rooms determined to be in fair condition typically exhibit routine signs of use and some light deterioration to wood surfaces, but no major wear or splintering. Appearance is still consistent overall.

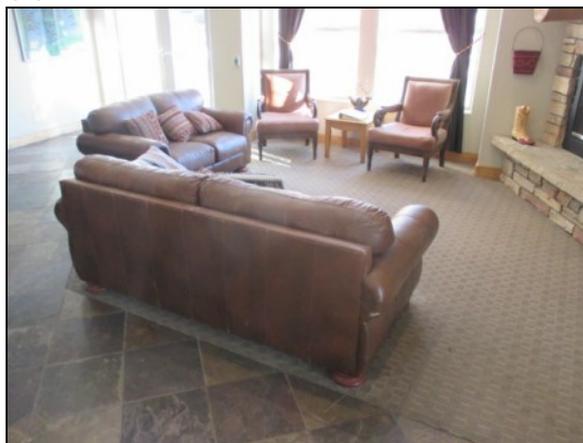
The furniture and decor appeared in fair condition. No damage, fading, or outdated appearances of the furniture was observed. This component recommends funding for periodic replacement/refurbishment of interior furnishings and decor such as furniture, artwork, window treatments, misc. decorative items, etc., in order to maintain a desirable aesthetic in the common areas. Cost estimates can vary greatly depending on the amount of items to be replaced at each project, and the style and quality of replacement options. Best practice is to coordinate this type of project with other interior projects such as flooring replacement, painting, etc. Schedule and cost estimates should be re-evaluated during future Reserve Study updates and adjusted as needed based on the client's good judgment.

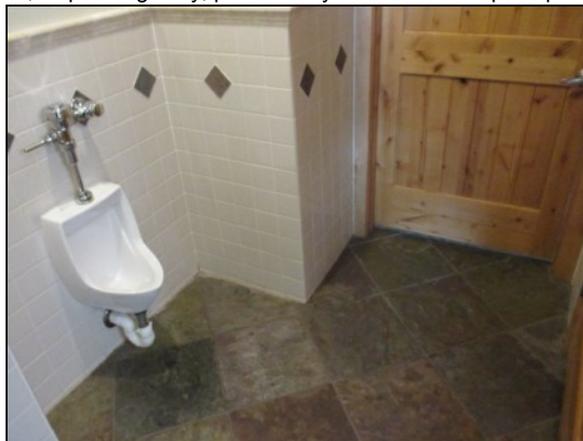
Good condition noted with no significant damage/deterioration noted. Prudent planning suggests setting aside funds for periodic large scale refurbishing which may include items such as: plumbing fixtures, vanity area, lighting, flooring, ventilation, accessories, décor, etc. As routine maintenance, inspect regularly, perform any needed local repairs promptly utilizing general operating funds.

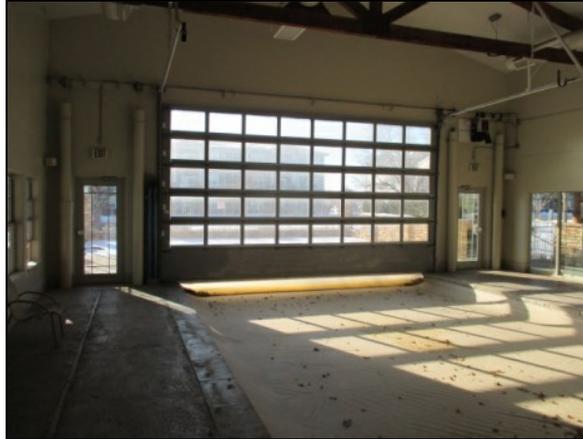
Comp #: 21490 Garage Door - Replace

Comments: Garage doors determined to be in fair condition typically exhibit more moderate signs of physical wear and tear.
